Port Bay Barrier Bar Assessment

Prepared for New York State Office of General Services and New York State Department of Environmental Conservation

Prepared by
Bergmann
EcoLogic

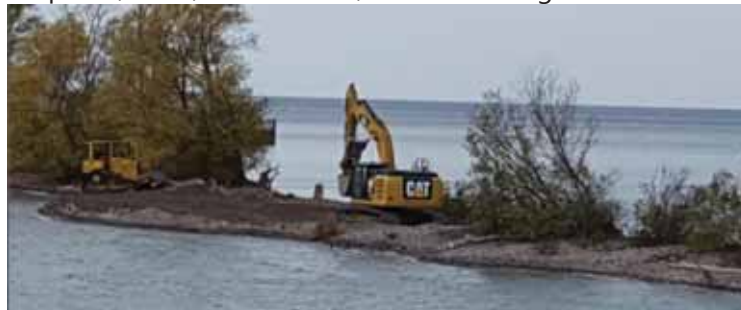
Apr. 10, 2016; WL=246.4 ft; Normal average WL=245.7 ft

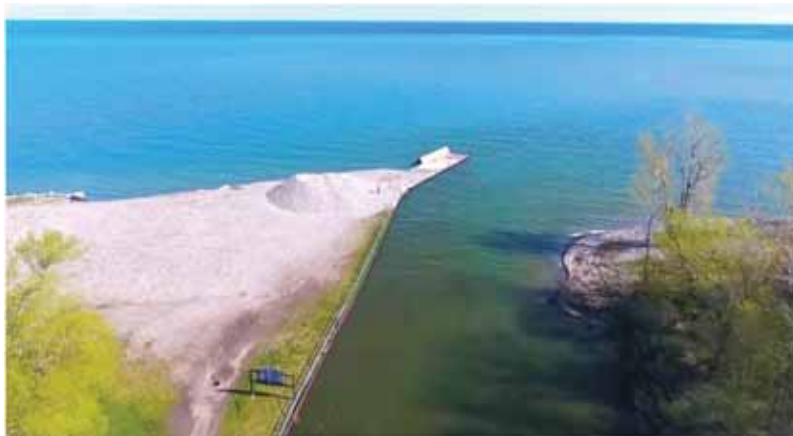
Part of the east barrier bar (repair of 2016, west of the breach) inundated because of high water level

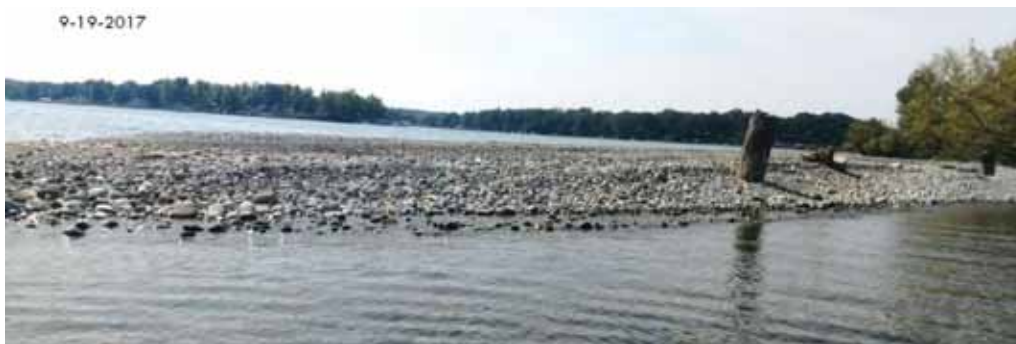
Closer look at the bar from the bay looking west, Oct. 18, 2017 (~WL 245.6)

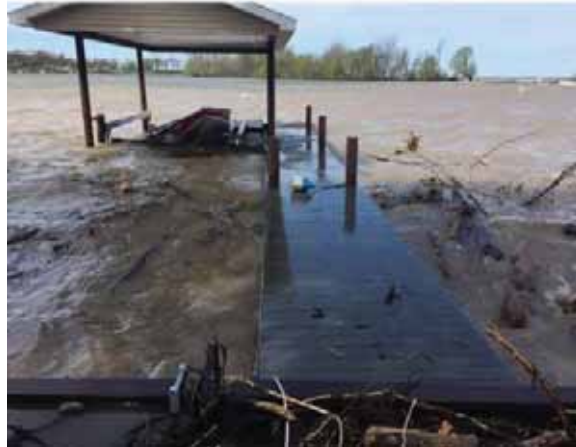
Figure 2.1-13 Damage During Breach of March 2017

May 3, 2017; WL=248.69 ft (normal average WL=246.10 ft)

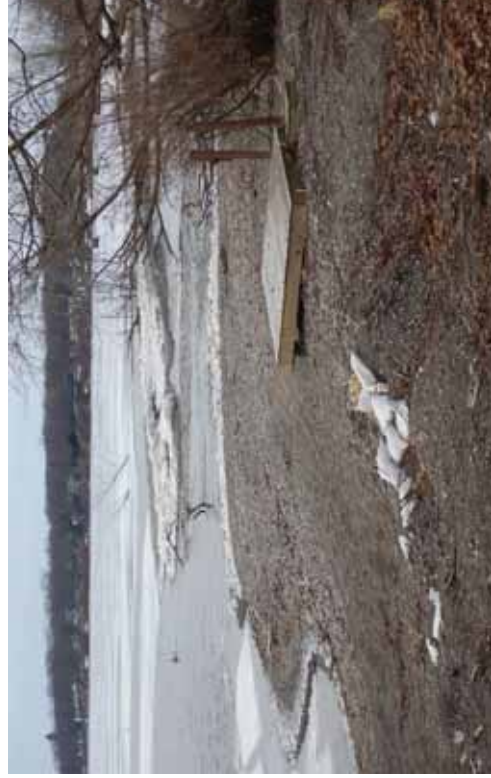
Figure 2.1-15 East Barrier Bar Breach of 2017 and Its Natural Repair (viewed Feb. – Apr. 2018)

Looking east (some flow from the bay to the lake; left to right)

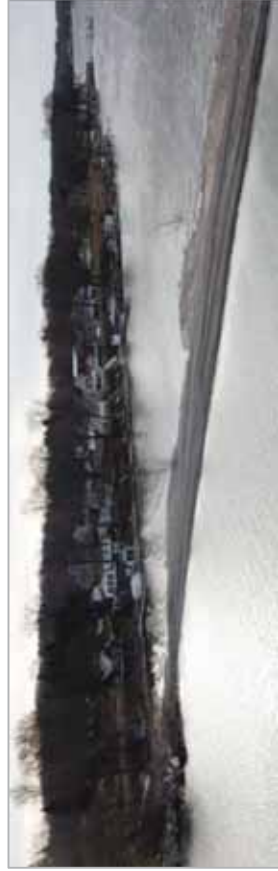
Above: Views of the breach of 2017 on the site visit of Feb. 17, 2018 (~WL 245.6)

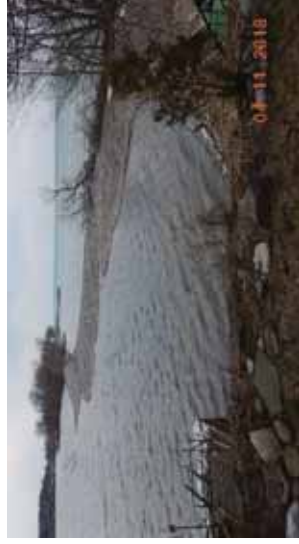
Drone view of the east barrier bar on Mar. 27, 2018; Natural repair of the breach; photo credit: David Aldrich, PBIA (~WL 245.5)

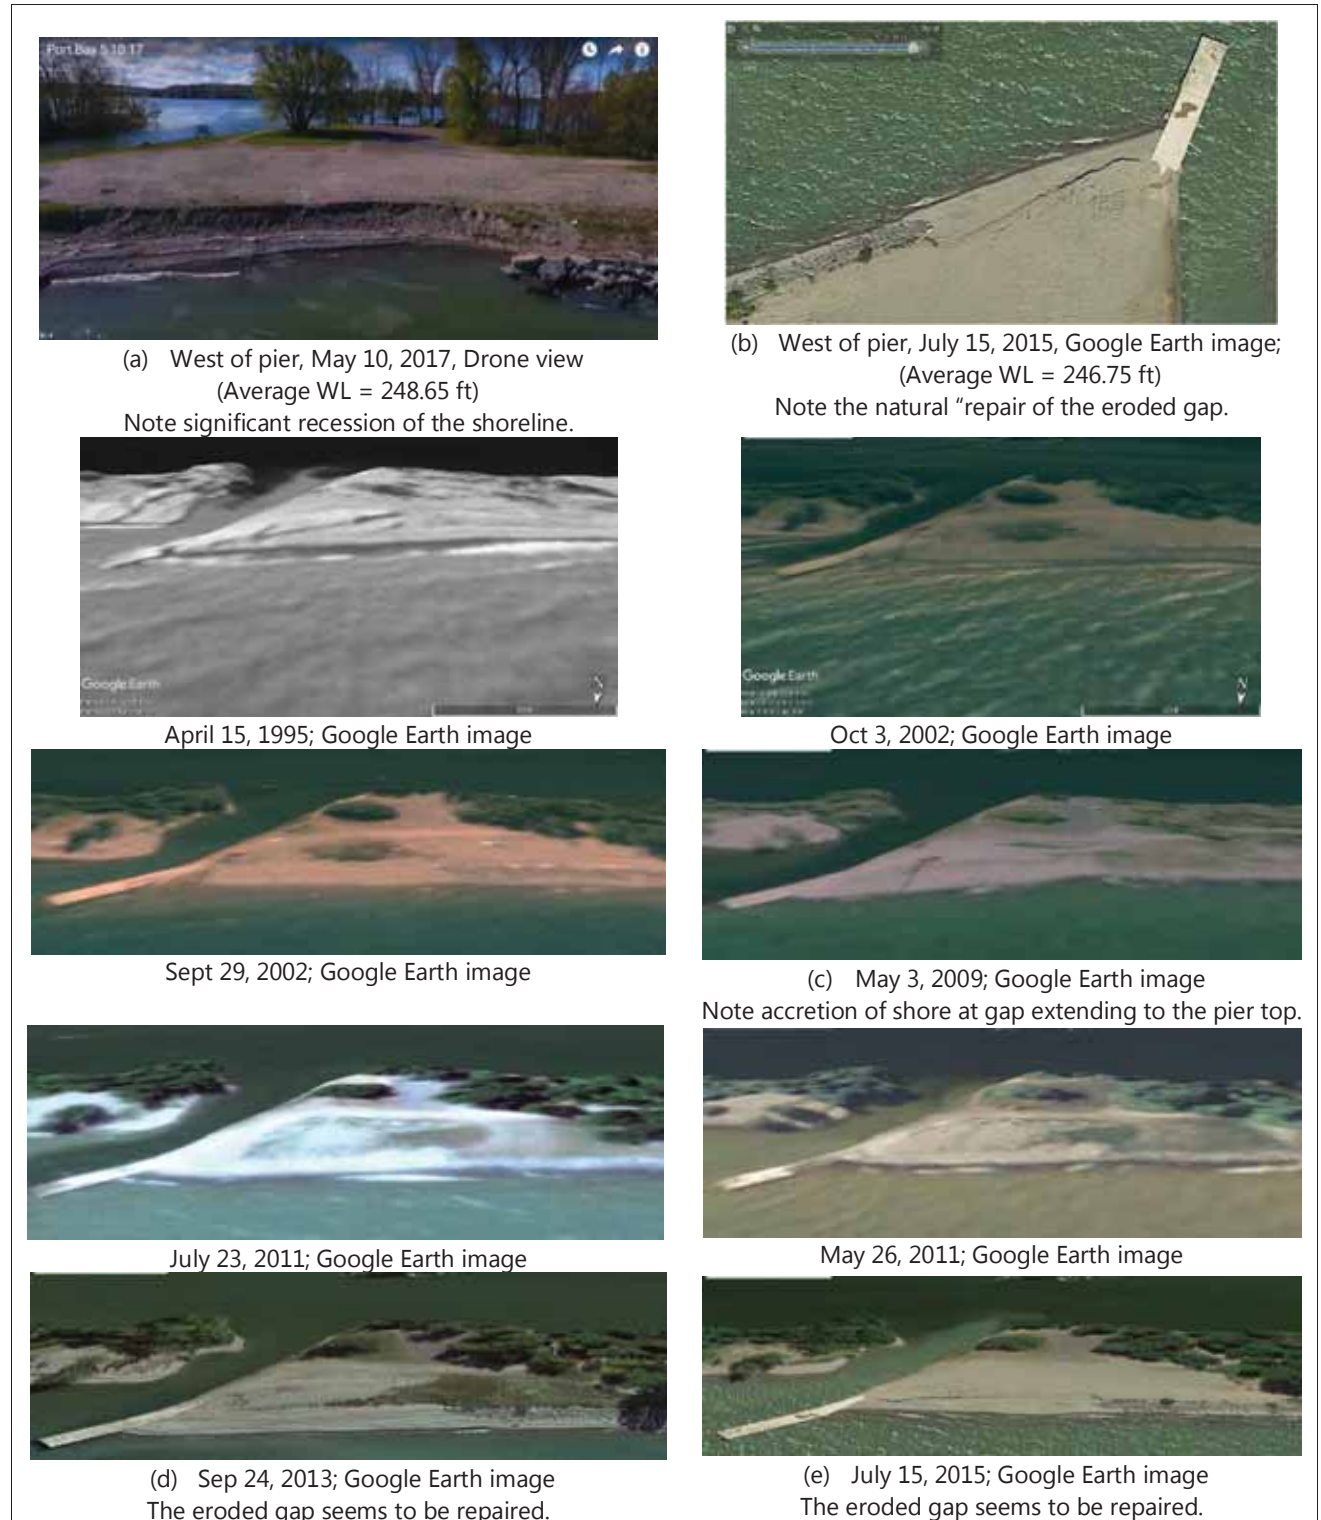
Figure 2.1-44 Natural Erosion and Deposition Along the Unprotected Shoreline West of the Pier

Unprotected shoreline gap west of the pier. The cyclic erosion of the unprotected gap between the pier and the existing rock revetment on the west of the pier seems to be regularly and naturally filled up by LST during storm seasons. No repair of this gap using hard structures seems to be necessary.
