Port Bay Barrier Bar Assessment

Prepared for New York State Office of General Services and New York State Department of Environmental Conservation

Prepared by
Bergmann
EcoLogic

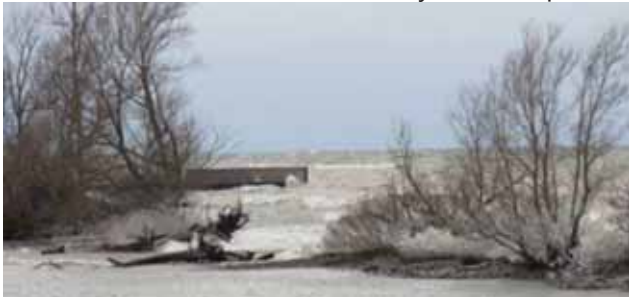
Trees washed into the bay (~WL 246.4 IGLD85)

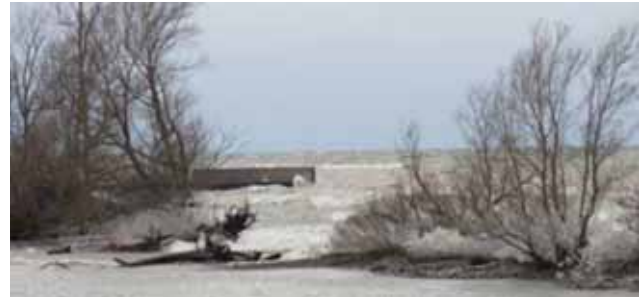
Trees washed into the bay (~WL 246.4 IGLD85)

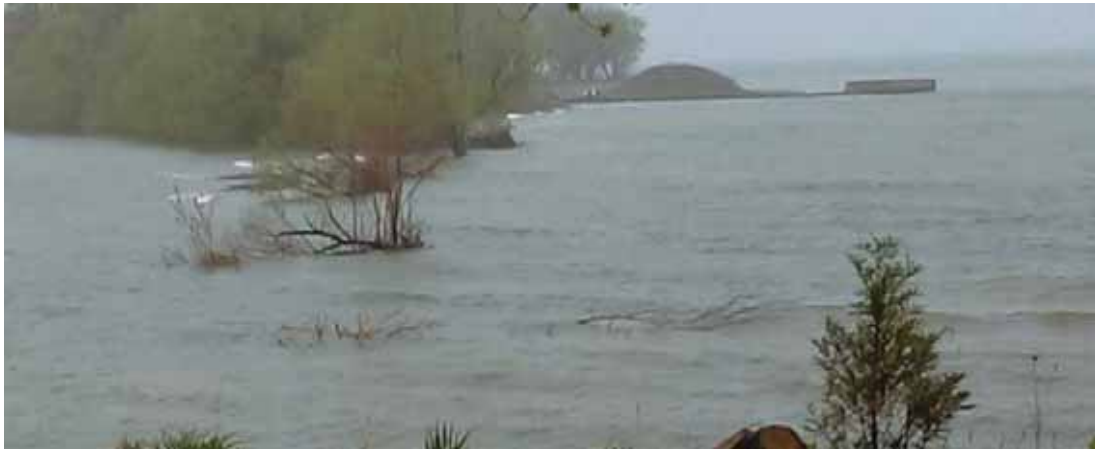
Breach widened in Apr. 2017 (~WL 247)

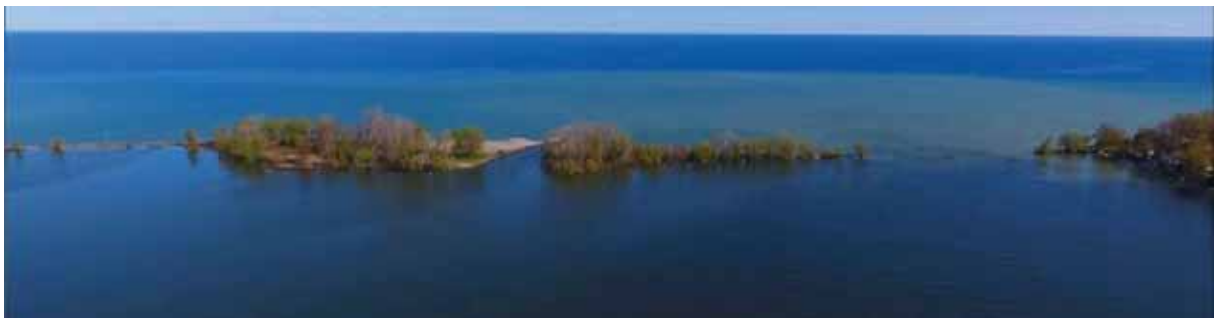
From bay looking toward bars (note the large east bar breach); May 10, 2017 (WL~248.6 ft)

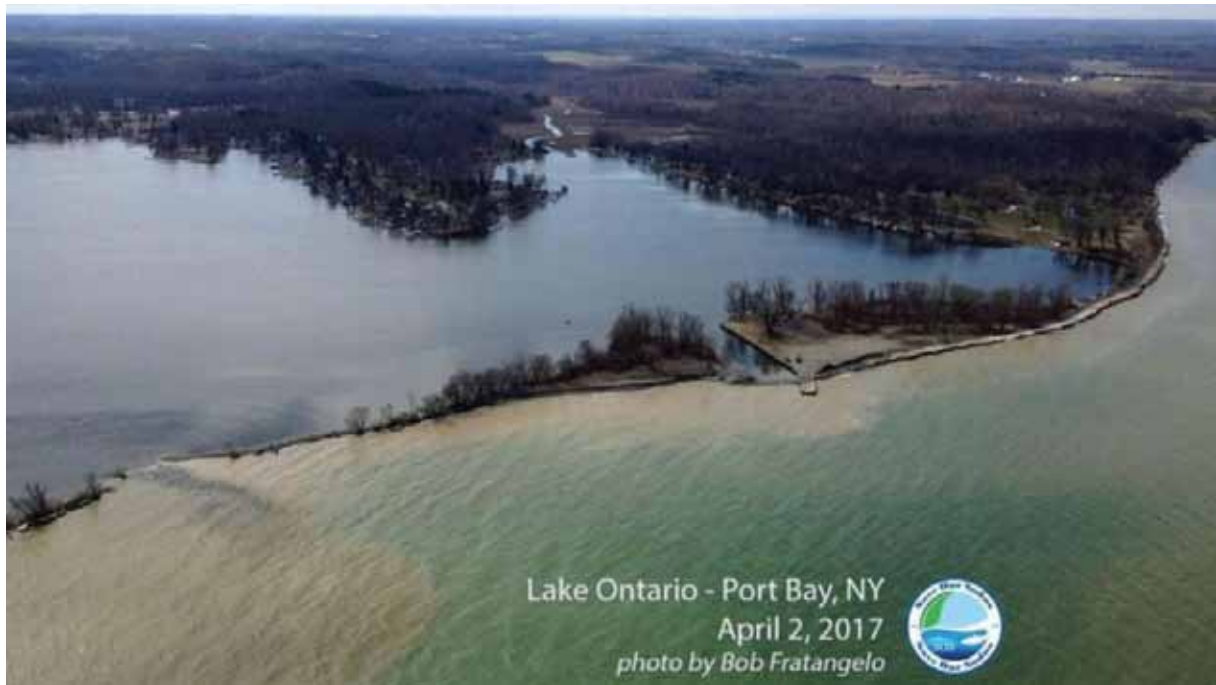
Breach of Apr. 3, 2017; channel outlet is filled in; WL=247.21 ft; Normal average WL=245.67 ft

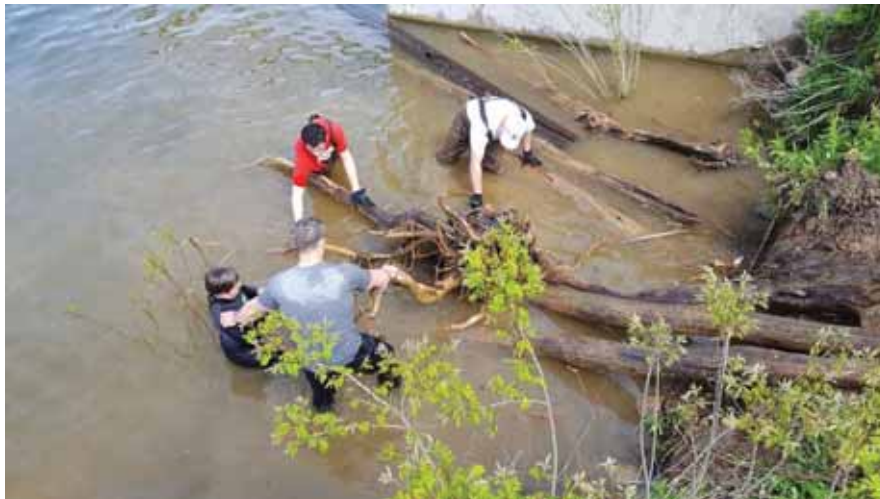
Logs & debris swept into the bay; May 29, 2017; WL=248.72 ft (normal average WL=246.23 ft)

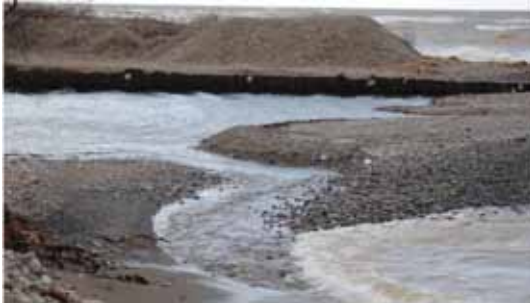
An obstructed channel allows the water levels in the Bay to rise to higher than lake levels. Eventually the channel/bay flow forces an opening to relieve water (Spoil #2 in the background)

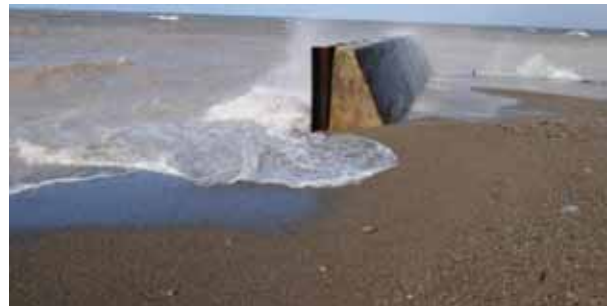
Looking north on the Pier during a winter storm; A portion of the materials that fill in the channel come over the top

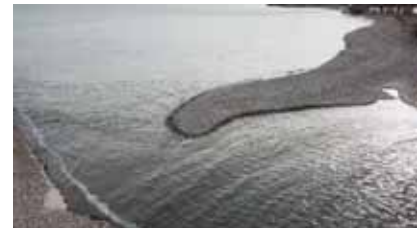
Deposition at the channel outlet to be dredged; looking east

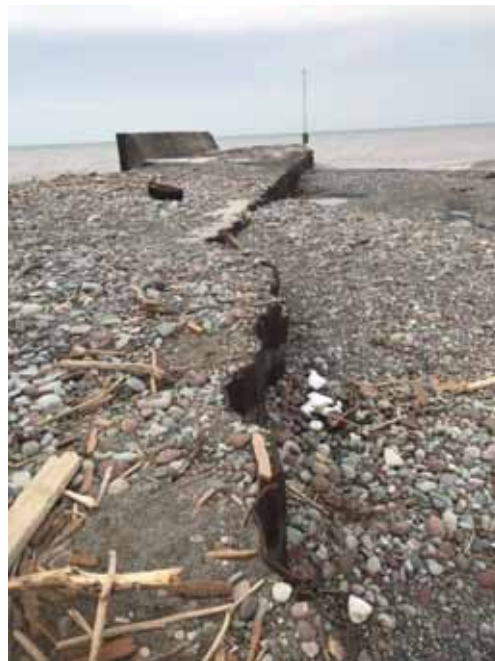
(b) Sediment deposit on and near the eastern edge of the pier

Note: The deposition pattern in (b) shows large accumulation of gravel immediately south of the concrete wall, an indication of gravel moving across and over the pier.

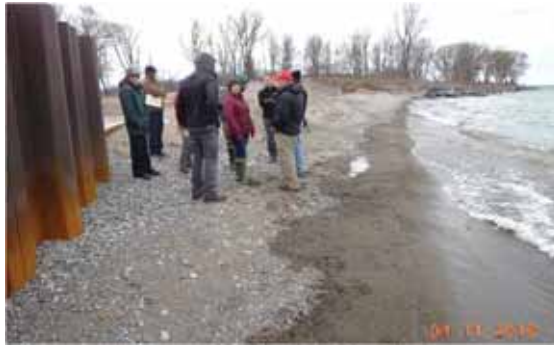
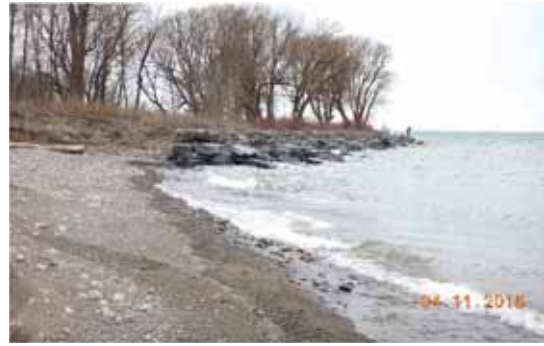
Apr. 11, 2018, site visit (~WL 245.8)

Apr. 11, 2018, site visit

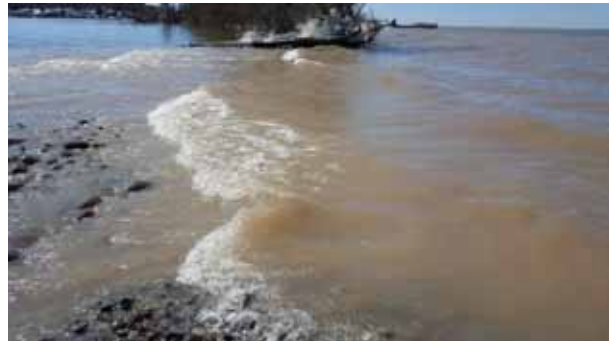
Waves from the lake to the bay through the 70-ft opening in the east barrier bar on Sunday Apr. 3, 2016

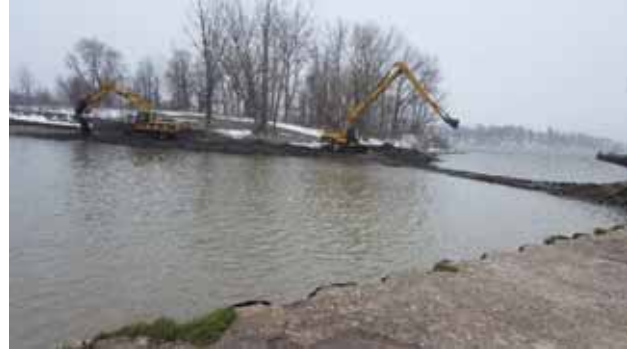
Dredging on April 6, 2016; looking south. Note gravel bar across the entire outlet.

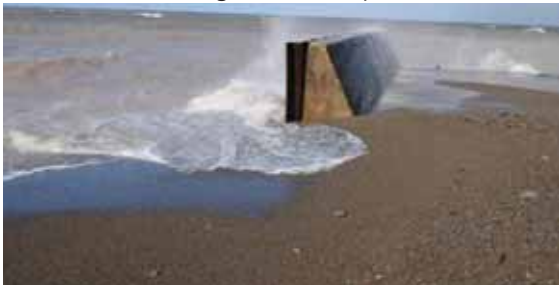
Gravel on pier, even at the toe of the concrete wall from the top of the wall; looking northeast

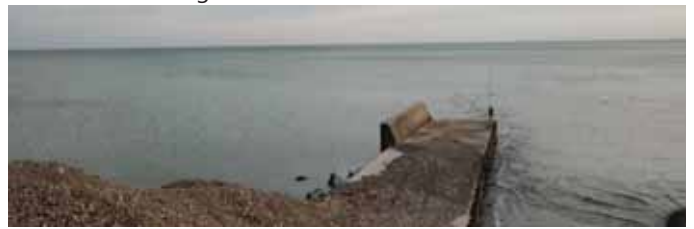
(a) Pile of gravel on the pier next to concrete wall from longshore sediment transport (LST); looking northeast

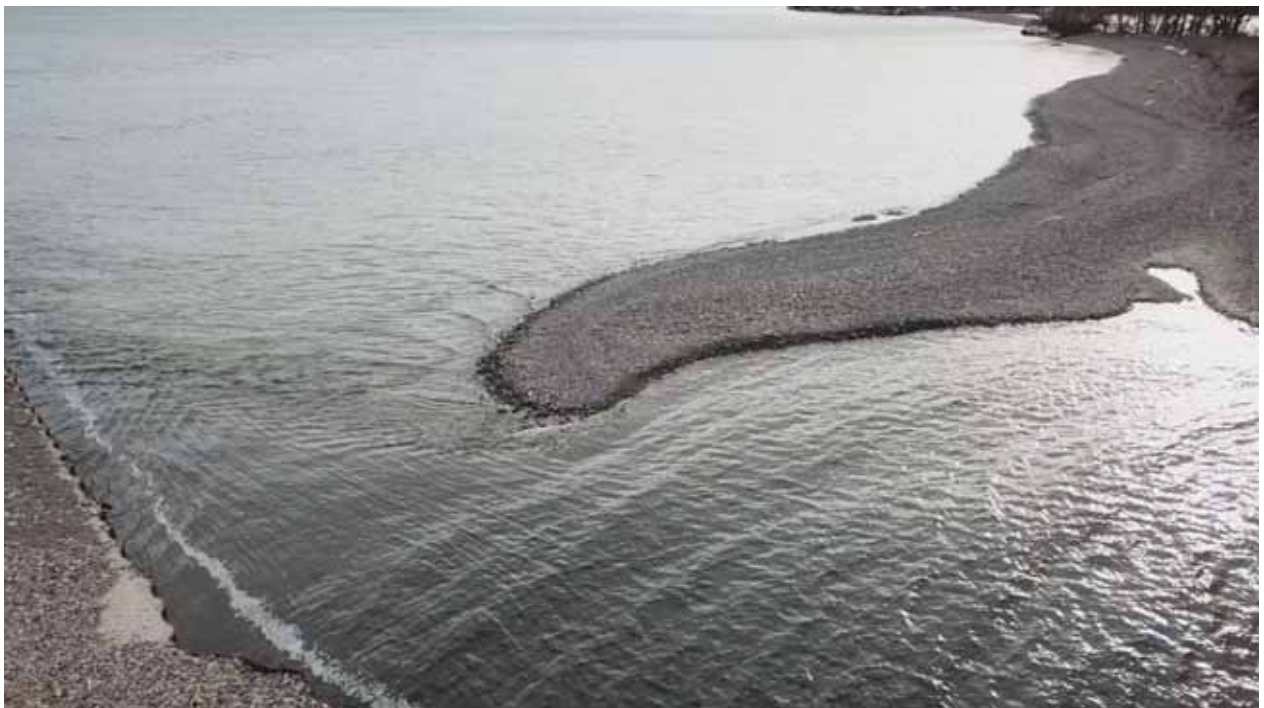
Gravel bar across the outlet; a narrow gap has been created by flow from the bay into the lake; Looking east from pier bend (Drone view, March 27, 2018; Photo credit: David Aldrich, PBIA)

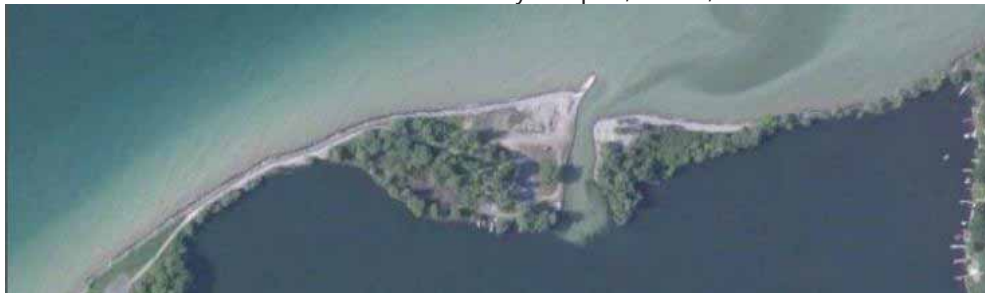
Impact of flow from the bay on the flow pattern;
2016 before east barrier bar breach

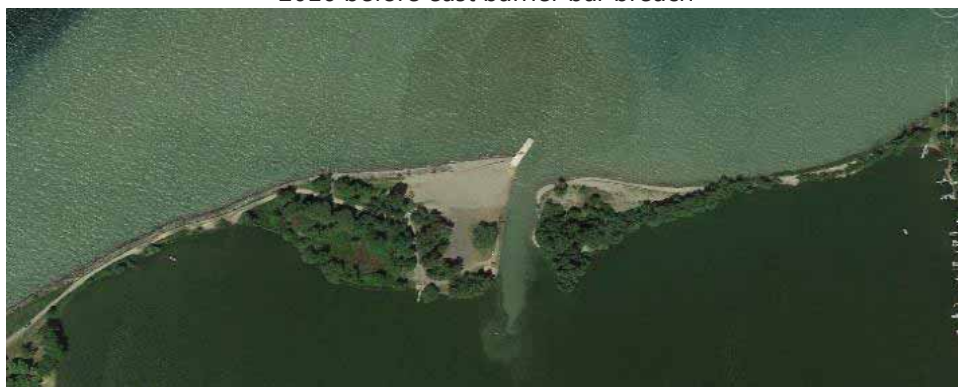
"Mud plume" into channel and near outlet,
Jul. 15, 2015

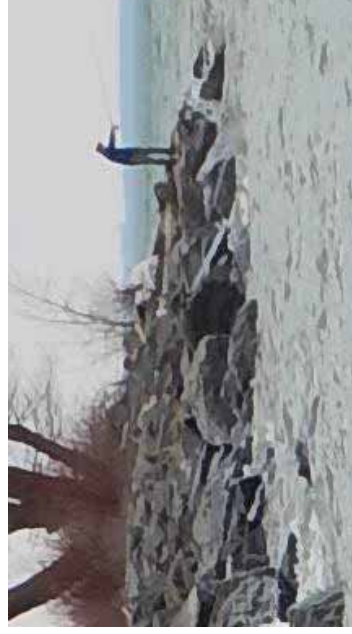
Figure D-3
Views of the Existing Revetment and Its Rocks Along the West Barrier Bar

From drone views on May 10, 2017 (consider the diameter of the large logs in the left and lower pictures \approx 6-8 in)

From site visit of April 11, 2018 (consider the fisherman as a 6-ft tall man)
