Port Bay Barrier Bar Assessment

Prepared for New York State Office of General Services and New York State Department of Environmental Conservation

Prepared by
Bergmann
EcoLogic

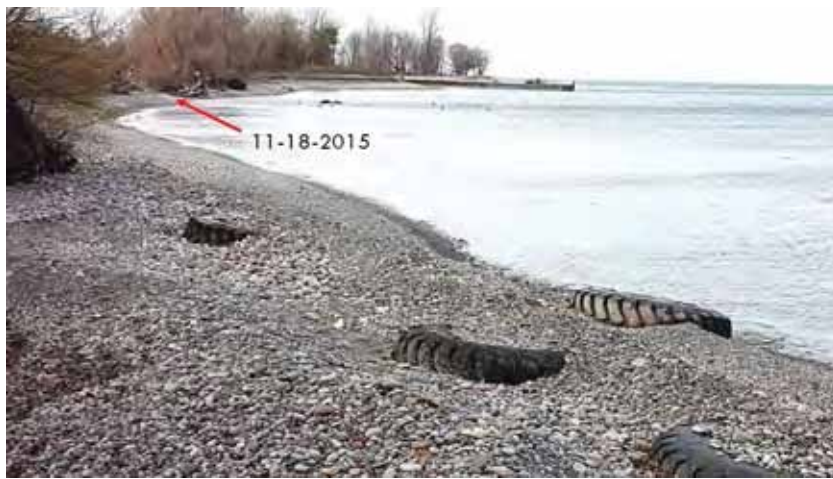
Location of the breach in Nov. 2015 (~WL 244.5 IGLD85)

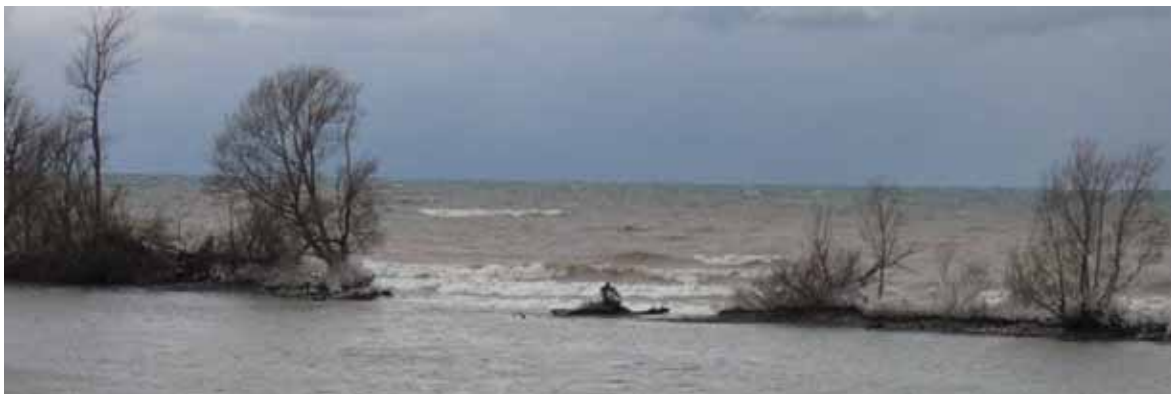
Breach of Apr. 3, 2016 (~WL 246.4 IGLD85)

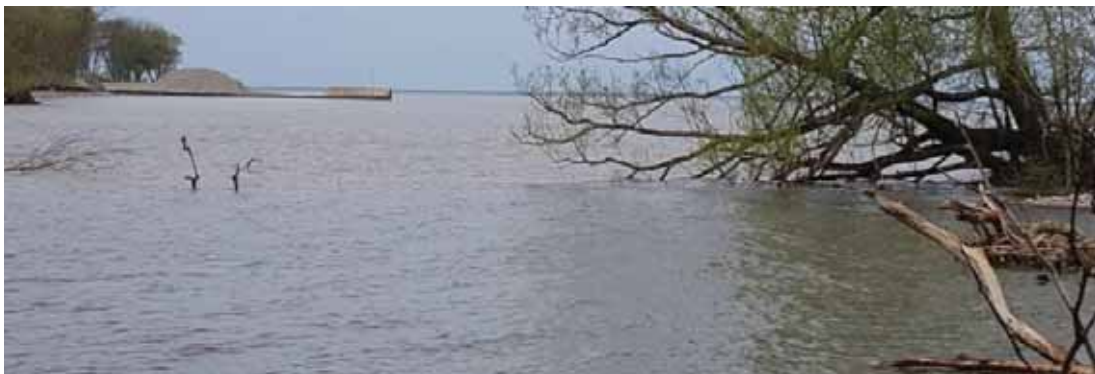
Breach as of May 2017 (~WL 248.5)

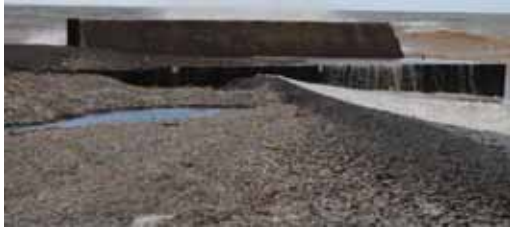
Fill in navigation channel outlet

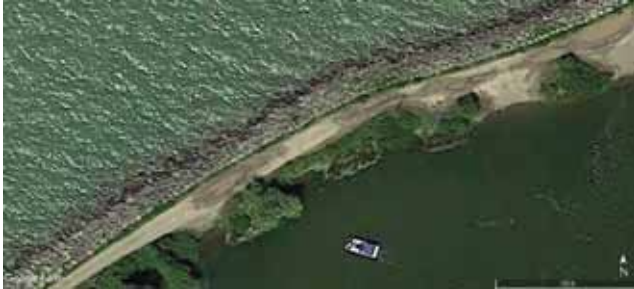
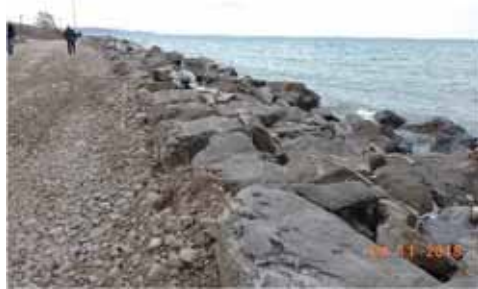
May 2015 (~WL 245.5)

May 2015; Google Earth image

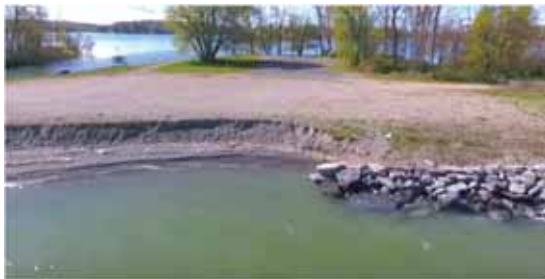
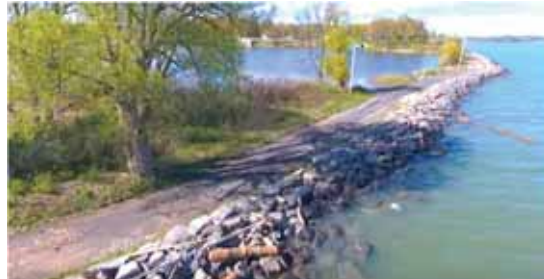
May 10, 2017, drone view (~WL 248.6)

May 10, 2017, drone view

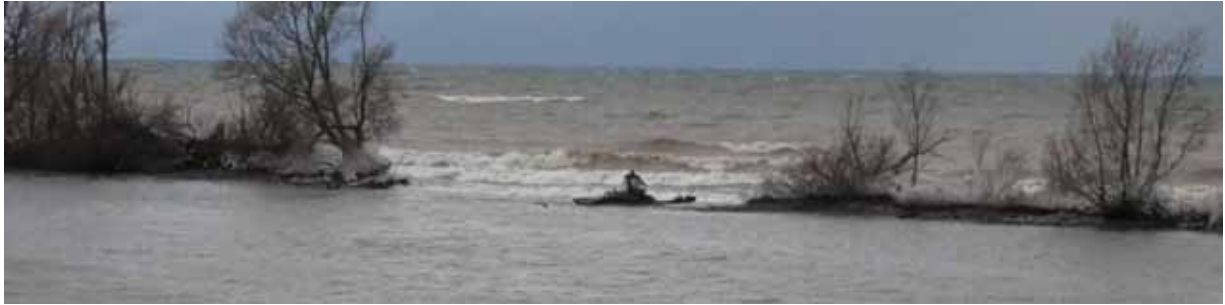
Waves in the lake hours after the breach of Apr. 3, 2016; looking north through the east barrier bar (~WL 246.4)

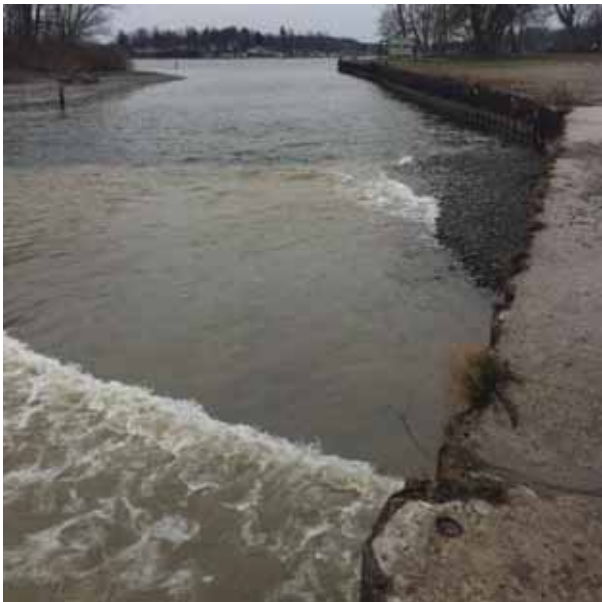
Waves entering the channel (looking south)

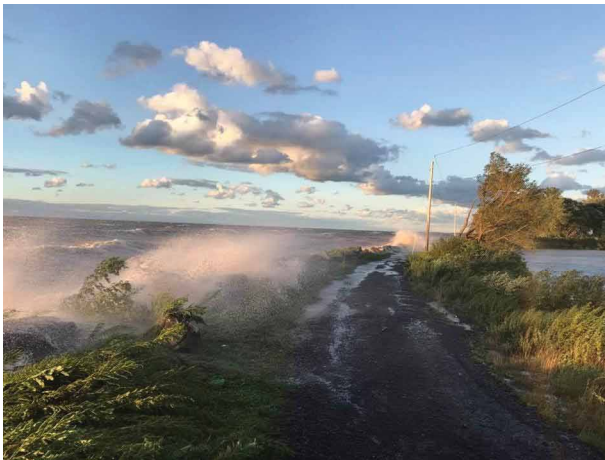
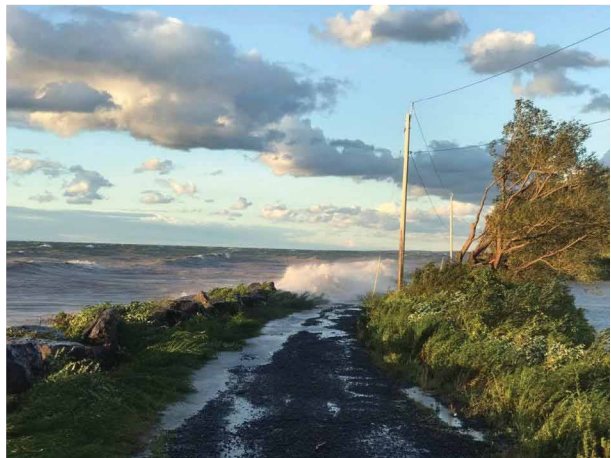
Wave action on the west barrier bar in early Aug. 2017; looking east; bay is on the right (~WL 247.8)

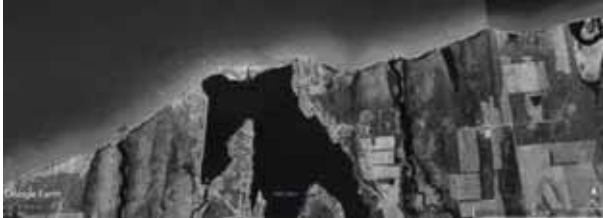
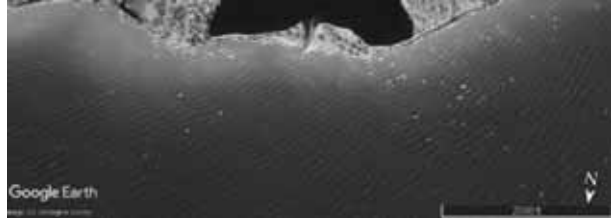
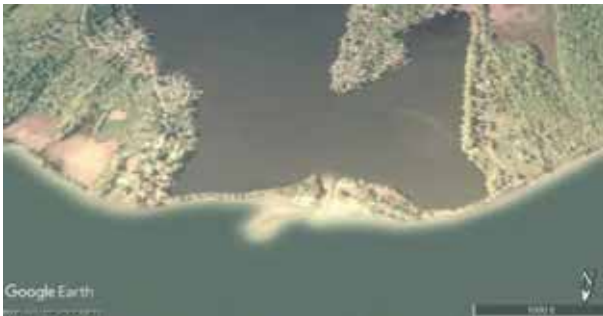
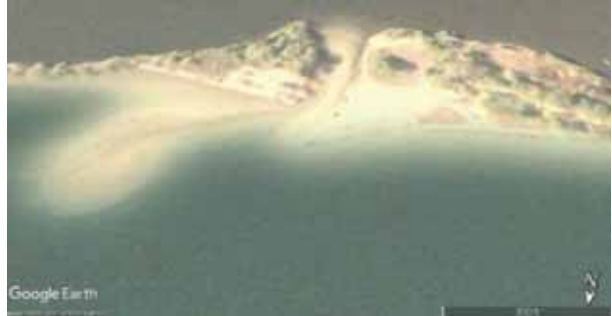
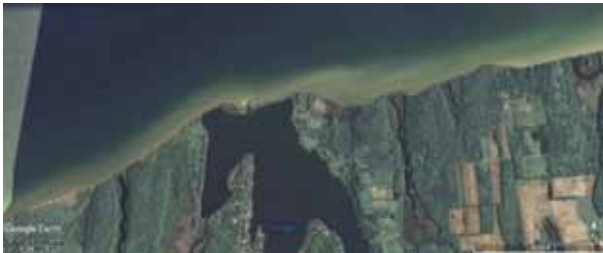
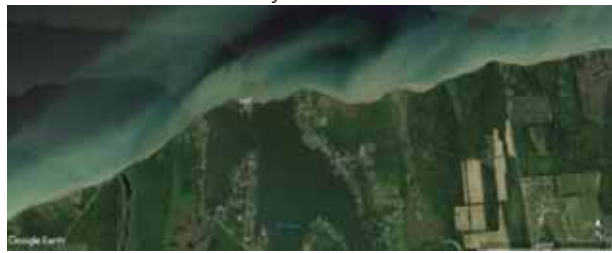
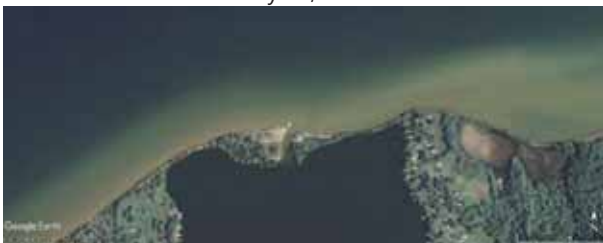
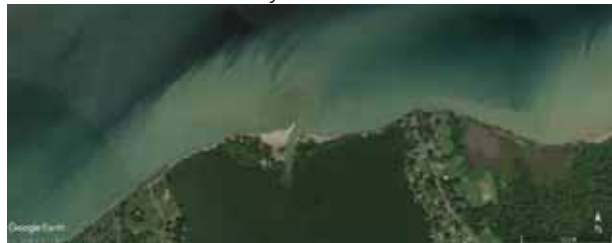
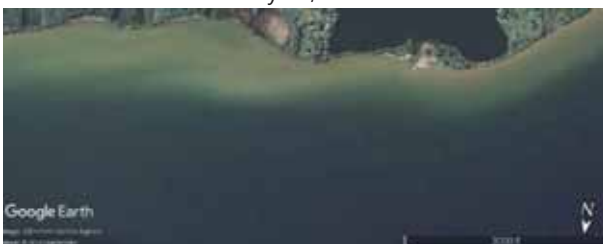
Figure 2.1-43 Indications of Active Sediment Transport Along the West Shoreline

Note an overall eastward movement of the sediment masses and plumes, in line with the predominant north-westerly wave direction.

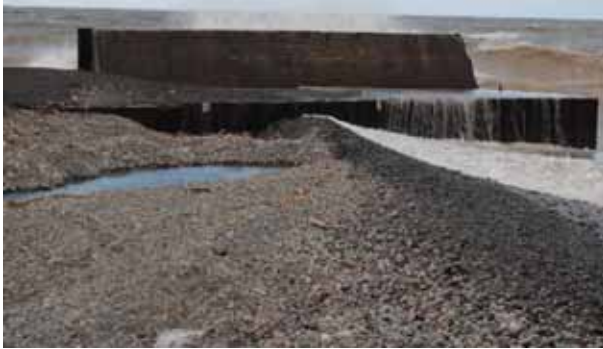
Filled-in navigation channel outlet; looking northwest. Note gravel on the pier.

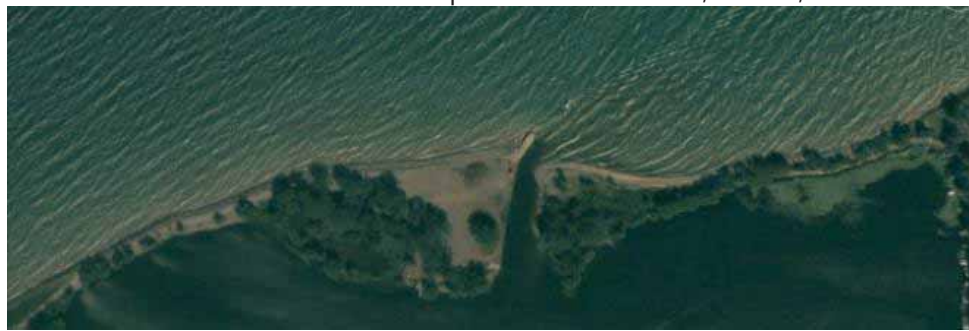
Wave fronts influenced by the pier, Oct. 3, 2002

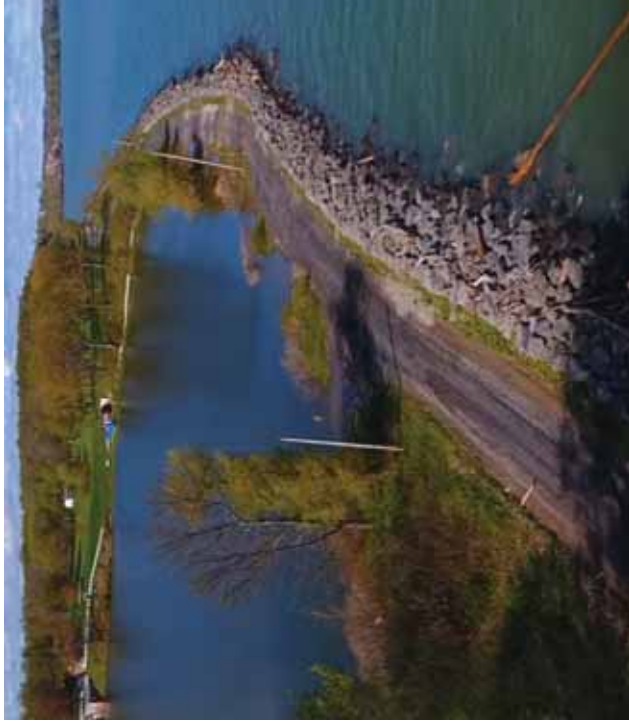
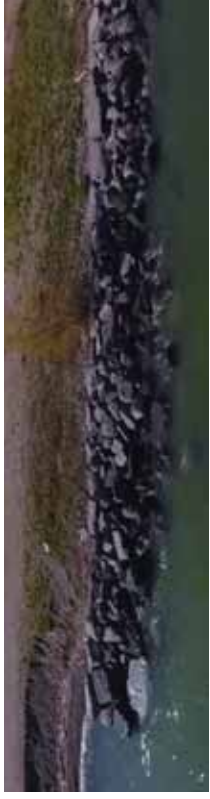
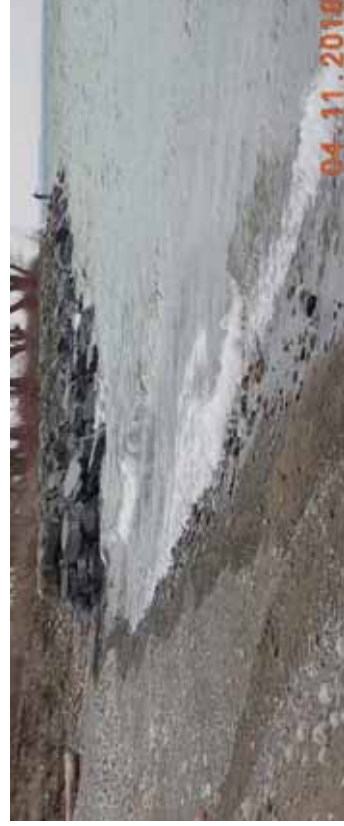
Figure D-3
Views of the Existing Revetment and Its Rocks Along the West Barrier Bar

From drone views on May 10, 2017 (consider the diameter of the large logs in the left and lower pictures \approx 6-8 in)

From site visit of April 11, 2018 (consider the fisherman as a 6-ft tall man)
